La Signy Farm Serre

Excavation of a Great War Observation Post

No Man's Land
April 2004

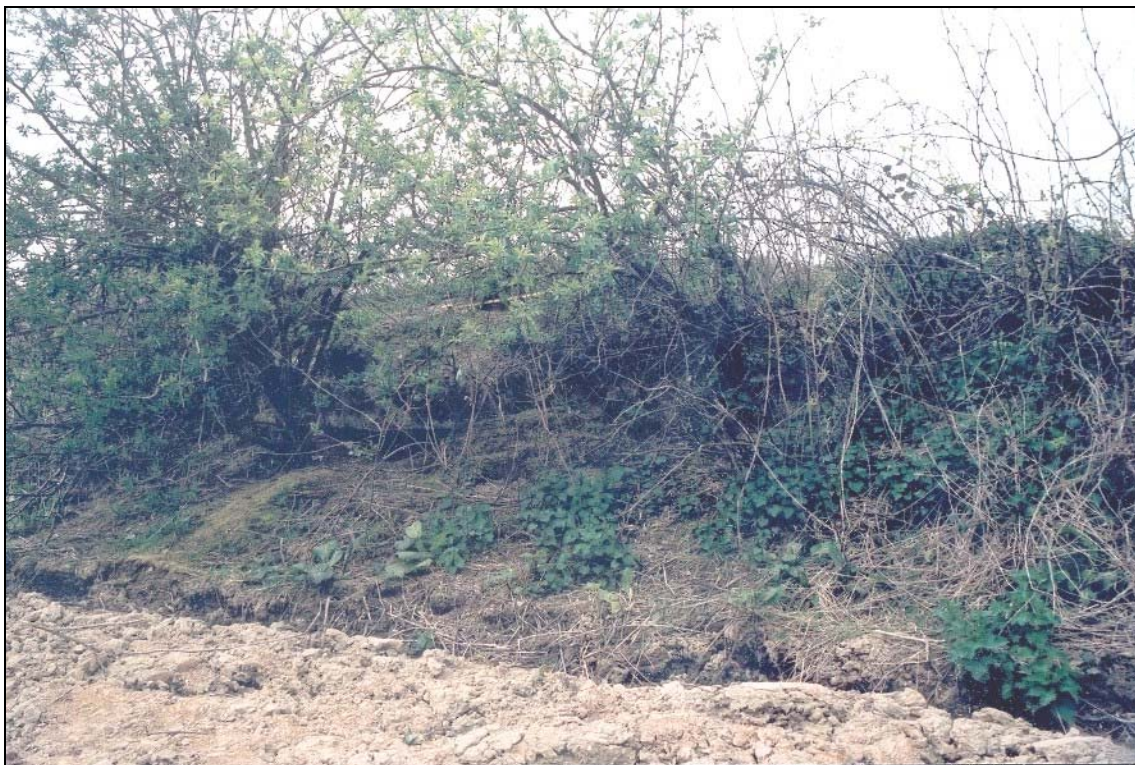
Fig. 2 Post prior to removal of vegetation (From north-west)

- 4.1 After clearance of initial vegetation (Fig. 2), excavation was continued by hand digging to provide a longitudinal section along the concrete structure (A-A on Fig. 6). This provided a profile along the concrete, as well as a section through the overlying soft deposits. At the western end of the structure this excavation was extended southwards to provide access to the entrance to the post. Clearance of the entrance allowed limited excavation within the internal passage of the post, but time constraints did not allow this to proceed further than the immediate area of the entrance.

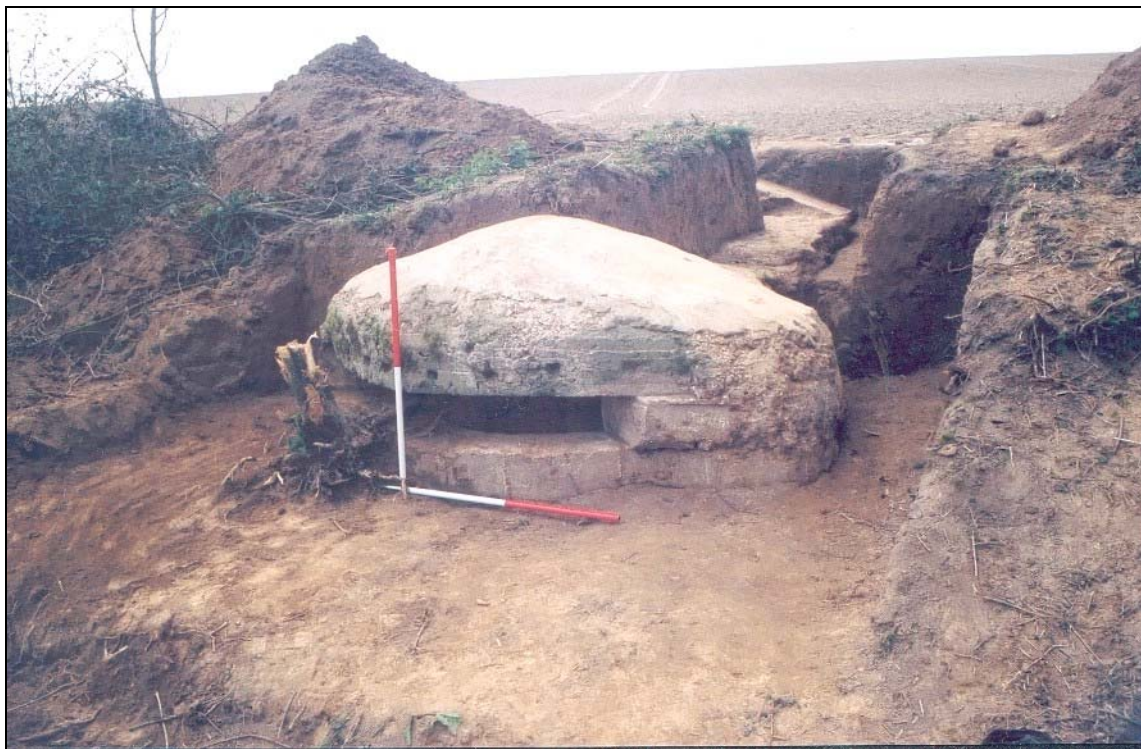
Fig. 3 Post as excavated (Scales 1m)

- 5.1 The fully excavated post is depicted in Fig. 3 and a measured plan and profile are provided in Fig. 6. A list of excavated contexts is provided in Appendix 1. The eastern end of the post consisted of a teardrop-shaped concrete position approximately 2.5m wide and 3m deep. It stood 1m above the level of the field to the east, which left the roof of the post broadly level with the ground surface to the west of the site. The lower part of

the structure and the aperture to the front had been constructed of curved, pre-cast concrete blocks, but these had not been assembled to a formal symmetrical design, rather they were inserted ad-hoc to create an irregular shaped structure. A domed concrete roof covered this part of the structure, covered with a smooth mortar rendered surface. A series of sockets were apparent in the sill above the aperture, with evidence of rusted-out angle irons, suggesting that iron supports once protruded from the front, possibly to support camouflage, or additional sandbag protection. Patches of greenish stain were apparent on the front face of the structure, these may be traces of camouflage paint, or may be a by-product of algae growth and weathering of the concrete.

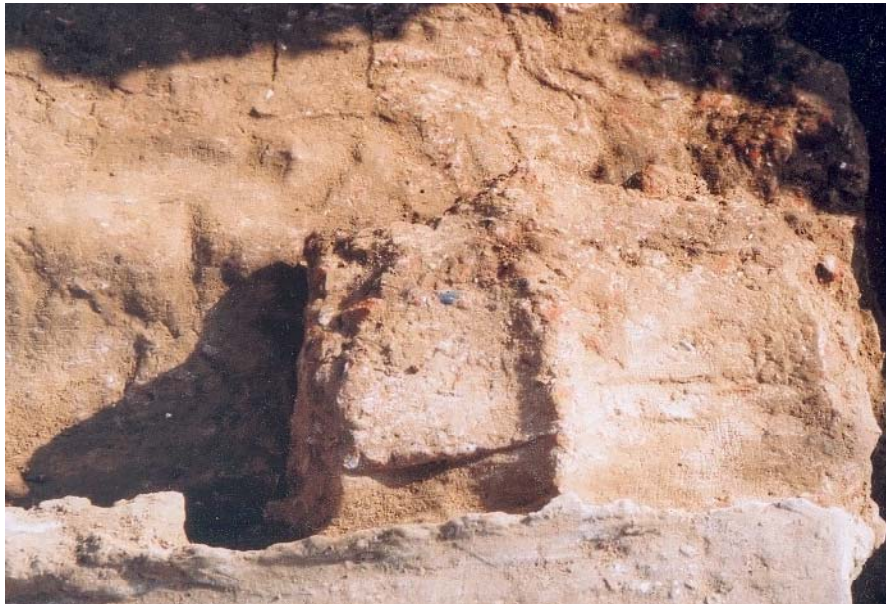
Fig.4 Sandbag impressions

- 5.2 The rear portion of the post consisted of a concrete corridor approximately 2.5m long and 1m wide. The construction method here differed from the front portion of the post. Externally the structure was formed of rough-cast concrete, and impressions of sandbags were preserved in the concrete (Fig. 4), to the extent that not only the shape of the bags but also the weave of the hessian was evident in the set concrete. It would

appear that the external part of the structure was banked-over with sandbags while the concrete was still soft, and that these formed an integral part of the structure. The fill material immediately against the structure consisted of silty-clay *liman*, with small quantities of military debris; shell fragments and spent rounds, suggesting that this material originally formed the fill of this sandbag covering, the bags themselves having decayed.

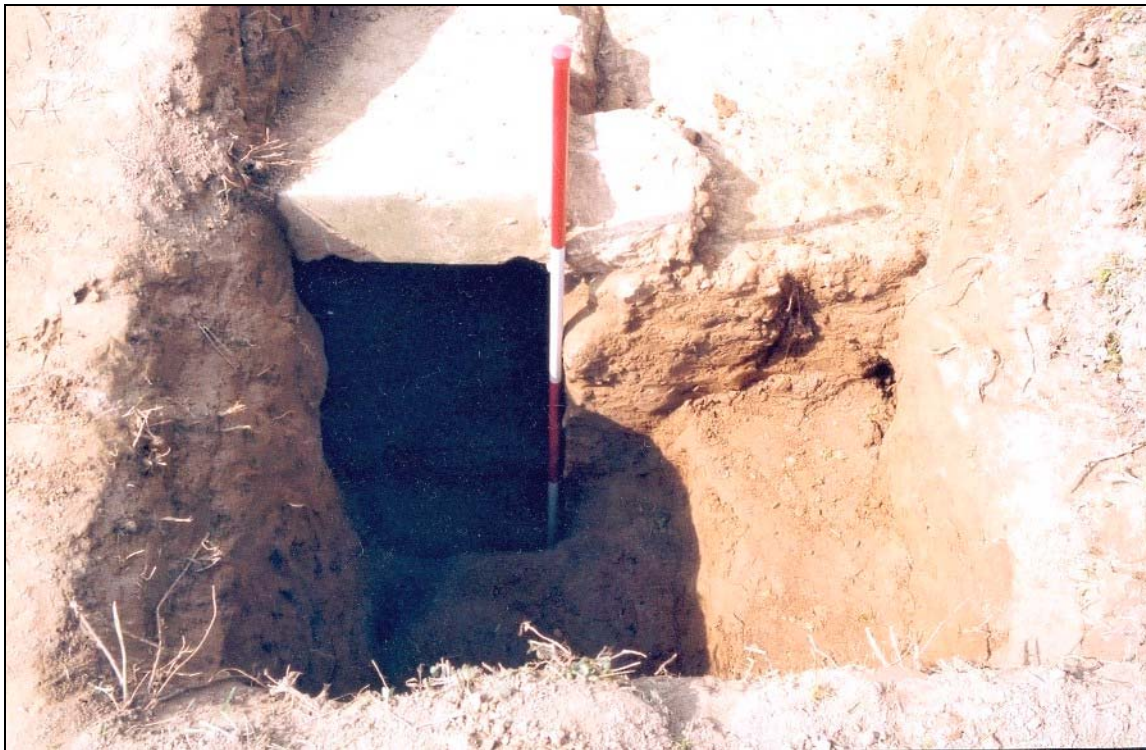
Fig. 5 Entrance (Scale 2m)

- 5.3 The entrance to the post was on the south side of the west end of the corridor, and consisted of a rectangular opening with a pre-cast concrete lintel, set at an angle with its south end higher, in order to enlarge the entrance opening. A concrete step, and part of a flat concrete floor were uncovered 1.5m below the level of the lintel. The interior of the post was entirely filled to ceiling level with clean silt. Thus it was not possible to examine more than the immediate entrance area in the time available for excavation. It is not clear how this material entered the structure but the location of the entrance against the field boundary bank may have resulted in a natural flow of silt into the interior over the past 85 years. Animal burrows were evident within this silt, entered via the frontal aperture. Where visible the internal walls were of smooth vertical concrete, it was not possible to determine whether this was pre-cast or poured against shuttering in-situ.
